MTL TR 90-53

FAILURE ANALYSIS OF THE LAU-7/A LAUNCHER RETENTION BAND ASSEMBLY

VICTOR K. CHAMPAGNE, Jr. and GARY WECHSLER
MATERIALS TESTING AND EVALUATION BRANCH

November 1990

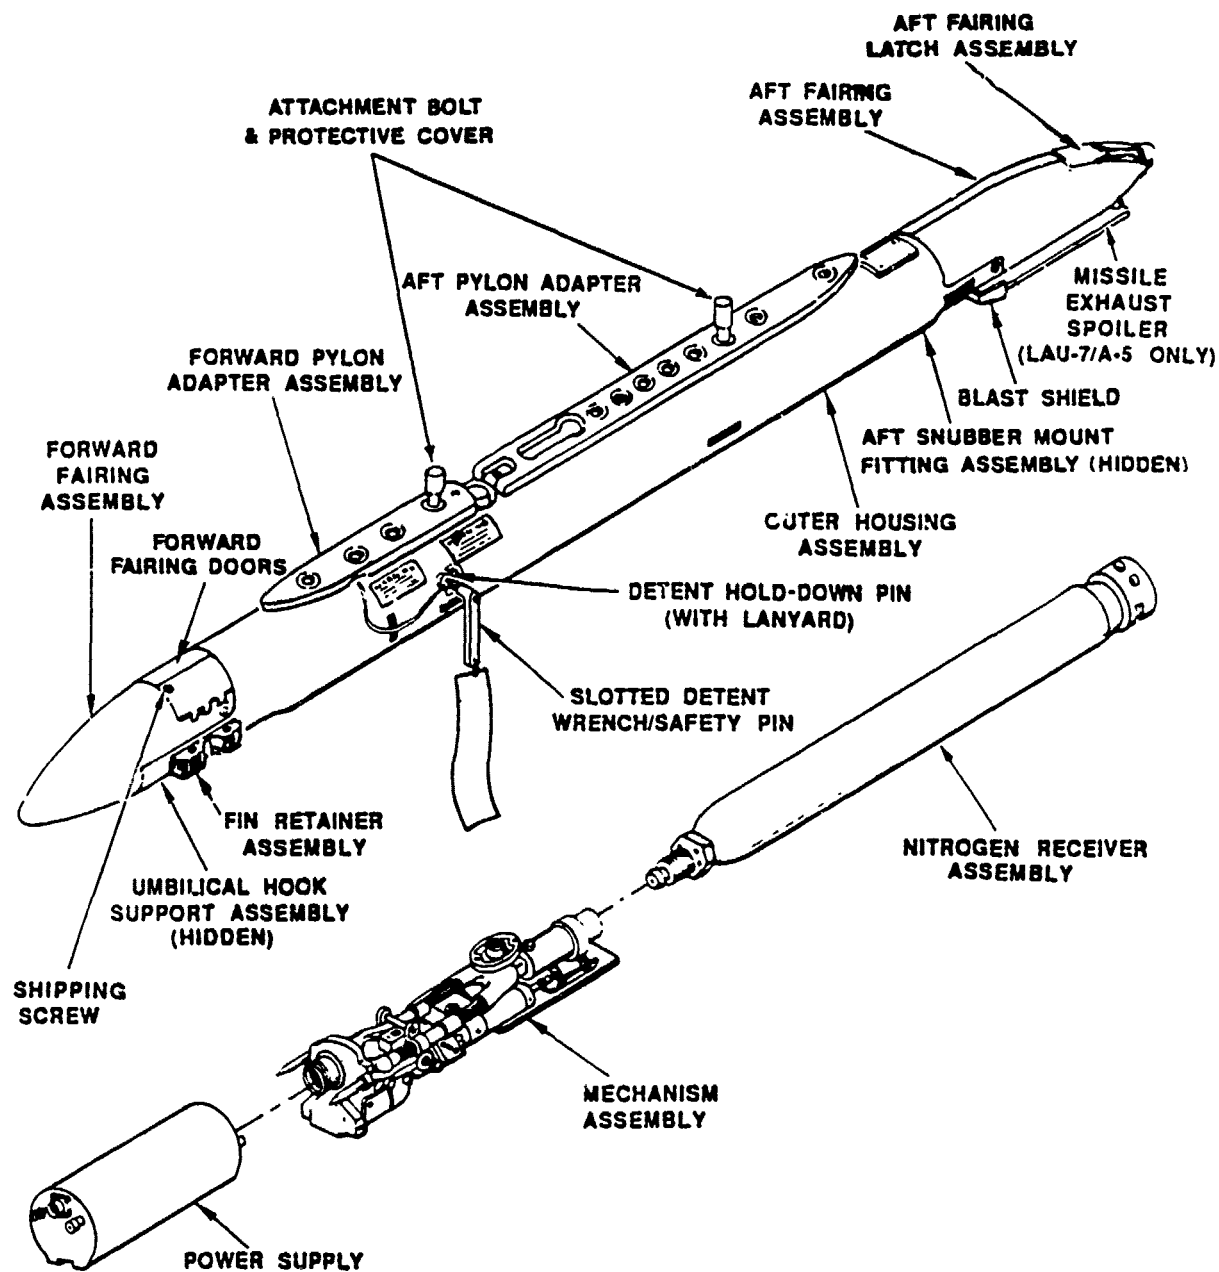
Figure 1. Illustration of the LAU-7/A Guided Missile Launcher assemblies.

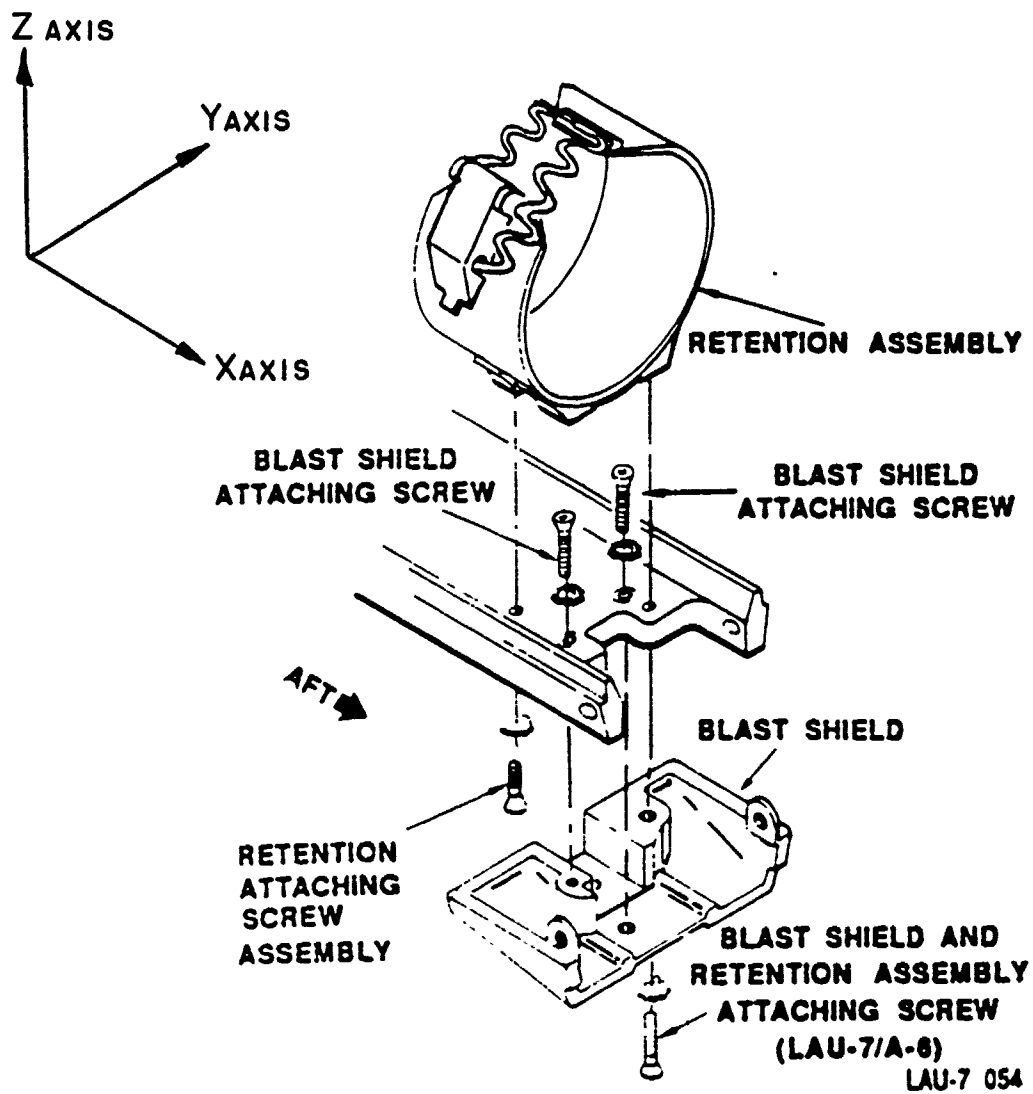
The LAU-7/A series of launcher had been installed on the wingtips of F/A-18 jets since the early 1980's. In this location the components are exposed to a more corrosive environment and subjected to increased vibration. The previous retention spring configuration (see Figure 2) which was designed to clamp down the retention band against the nitrogen receiver, was inadequate to secure and prohibit it from rotating free from the control valve. In several instances, the retention springs also fractured. To remedy the problem a more durable liner was bonded to the inside surface of the retention band (see Figure 2) and the retention spring was fabricated from larger diameter wire stock.

Figure 2. Schematic showing the retention band assembly.

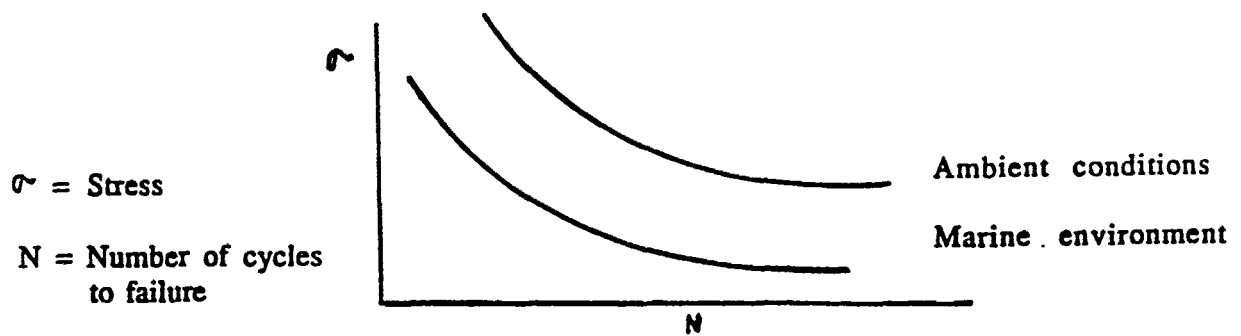
Figure 37. Graph showing the detrimental effects of corrosion on the fatigue life of a material.

3. If fatigue failures continue to occur after 1 and 2 above are implemented, this may indicate that the spot welds do not have adequate strength to withstand the service conditions and may not be the proper welding process for this application. In addition, corrosion within sites previously identified may be initiating fatigue cracks. The LAU-7/A series of launchers have been installed on the F/A-18 wingtips, since the early 1980's, which is a more damaging location. The launchers are exposed directly to the environment and are subjected to an increased amount of mechanical vibration and shock loading. These factors can decrease the fatigue life of the spot welds, especially if corrosion becomes involved in the mechanism of failure, as shown in Figure 37.
